Quila Granite – Warehouse

ArmourMate®

Project: Quila Granite Warehouse

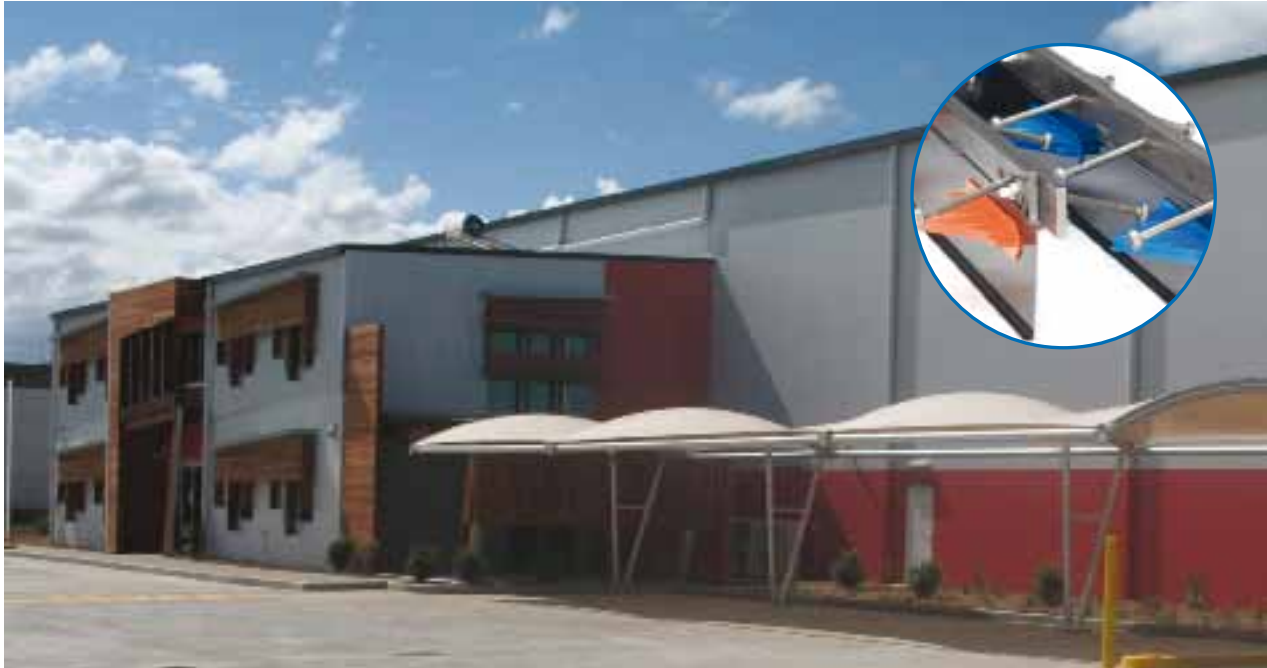
Quila Granite's South Brisbane warehouse facility had a number of slab requirements including significant loads from granite storage and movements from hard-wheeled, high-load traffic on a daily basis. Danley® provided the patented ArmourMate® joint armouring system resulting in an estimated saving of \$42,000 over the lifetime of the slab.

The ArmourMate® joint armouring systems are specifically designed for commercial and industrial applications where the concrete slab edges are exposed to traffic. Without protection, these joints will breakdown resulting in costly cracks and holes – damaging vehicles and tyres. ArmourMate® protects the joints and extends the operational life of the slab.

ArmourMate® comes in a range of grades flexible to project requirements. Douglas Constructions chose Hyper ArmourMate® for areas that receive high traffic flow – increasing protection of the warehouse floors from heavy loads and wear from intense forklift and truck use.

Danley's Econo ArmourMate® was also used in areas receiving a medium level of traffic from cushioned-tyre vehicles. Econo ArmourMate® is ideal for large wheel and cushioned-tyre traffic which has less potential to cause damage.
